Water Licence File# W2009L2-0001

Re: Notification of requirement to conduct daily inspections / monitoring of the LLCF;

Recommendation to temporarily cease deposition of Fine Processed Kimberlite into Cell B.

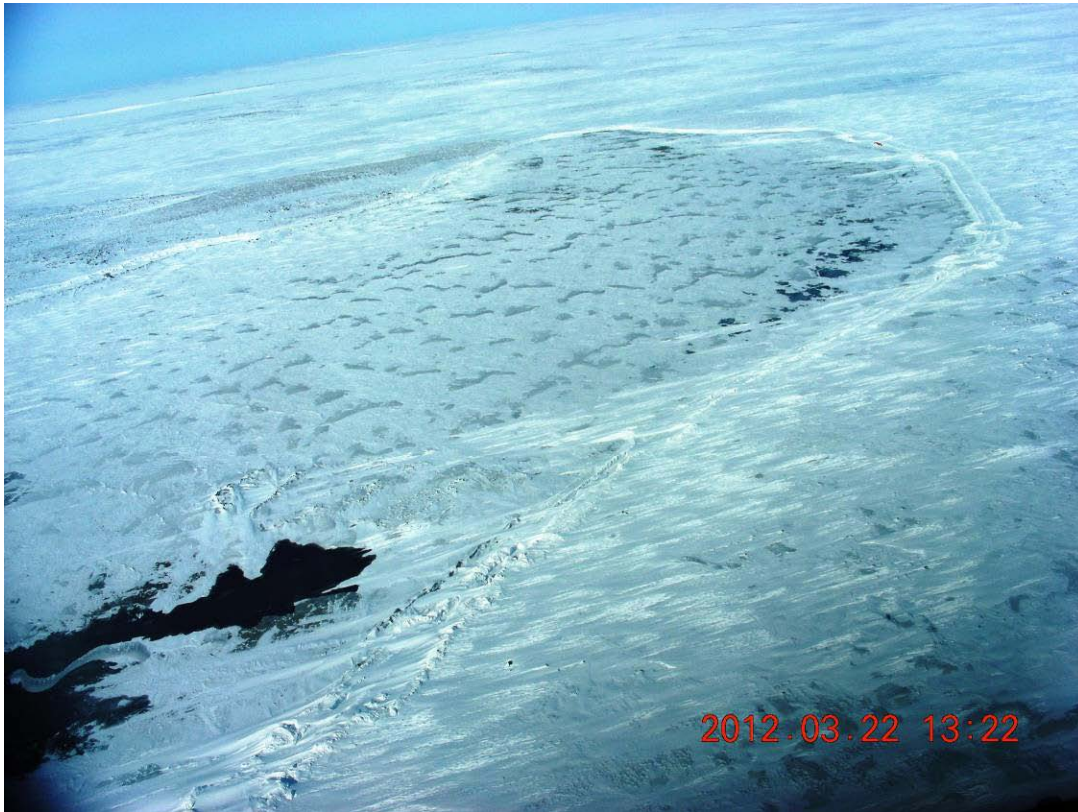
Cell A – East Access Road blocked due to snow drifts on March 22nd, 2012

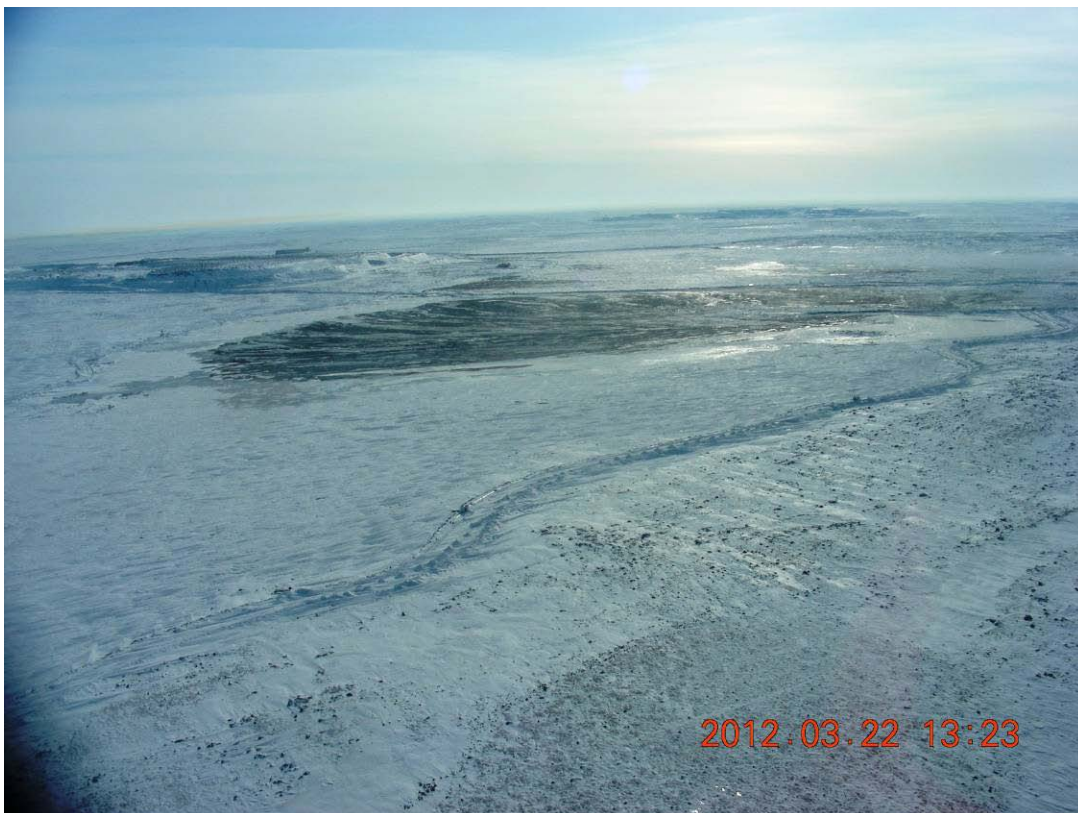
View of Cell A – Looking South (Recent FPK Deposition area is the darker area)

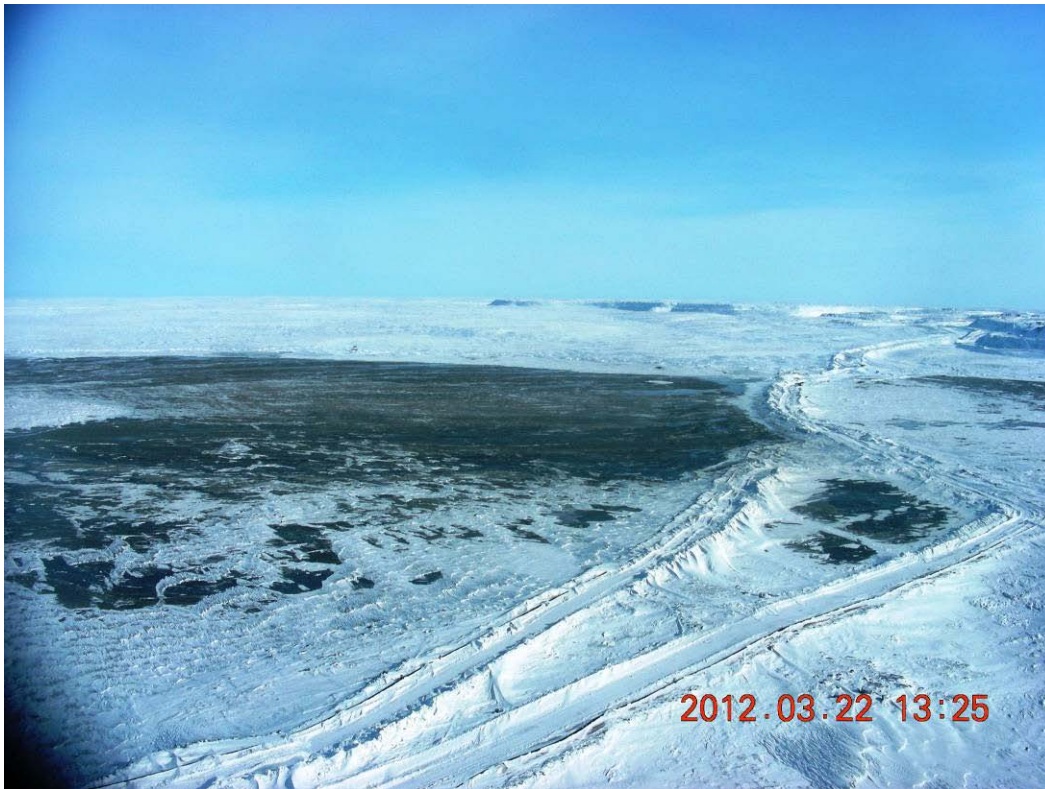
There are concerns as previously identified in the September 21st, 2011 AANDC Inspection Report that there may be potential for the single culvert under Dyke B to plug as Fine Processed Kimberlite encroaches in on this small drainage culvert. During spring freshet it is conceivable that this culvert could block with ice impeding proper drainage. Once spring freshet concludes for the season BHP Billiton Diamonds may be in a better position to assess the remaining holding capacity of Cell B for further continued deposition of Fine Processed Kimberlite.

Cell B – Kimberlite Deposition up against Dyke B

Likewise, at this time it is recommended that deposition of Fine Processed Kimberlite into Cell B of the LLCF be temporarily ceased with all Fine Processed Kimberlite diverted into either Cell A or Cell C until such a time that spring freshet has concluded. The aerial inspection recently conducted by AANDC over the Ekati mine site on March 22nd, 2012 revealed that deposition of Fine Processed Kimberlite into Cell B is rapidly reaching the maximum holding capacity for this particular Cell. (See attached photos)

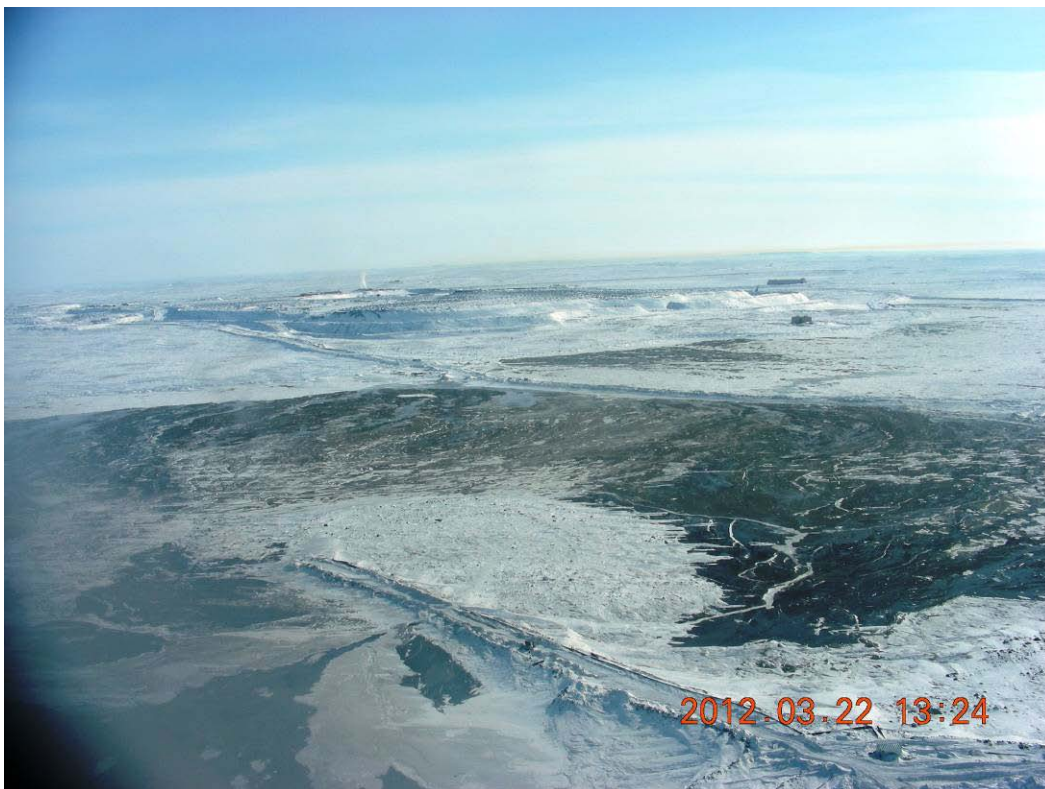
Cell B new jetty – It appears Cell B is nearing its maximum hold capacity.
Only a small area of exposed tundra remains uncovered in Cell B.
