**KOALA LAKE WINTER ACCESS ROAD
INVESTIGATION 1994/95
FINAL REPORT
113418**

5 0	ICE THICKNESS SURVEY MARCH 28 - APRIL 03, 1995	5 - 1
5.1	General Information	5 - 1
5 2	Data Processing	5 - 3
5.3	Subsidiary Measurement	5 - 14
5.3 1	Snow Data	5 - 14
5.3 2	Road Cross Section and Crack Pattern	5 - 14
5 3 3	Investigation of the "boil" on MacKay Lake	5 - 15
5 3 4	Observations Along Fish Camp Access Road - April 02, 1995	5 - 16
6 0	DYNAMIC RESPONSE MEASUREMENTS - APRIL 02, 1995	6 - 1
6 1	Background	6 - 1
6.2	Purpose	6 - 1
6 3	Test Location	6 - 1
6 4	Apparatus	6 - 3
6 5	Test Procedure	6 - 3
6.6	Data Reduction	6 - 3
6.7	Accelerometer Data	6 - 14
6.8	Critical Speed	6 - 15
6.9	Comparison With Other Dynamic Magnification Measurements	6 - 17
7 0	SUMMARY AND CONCLUSIONS	7 - 1
8 0	RECOMMENDATIONS	8 - 1
9 0	ACKNOWLEDGEMENTS	9 - 1
10 0	REFERENCES	10 - 1

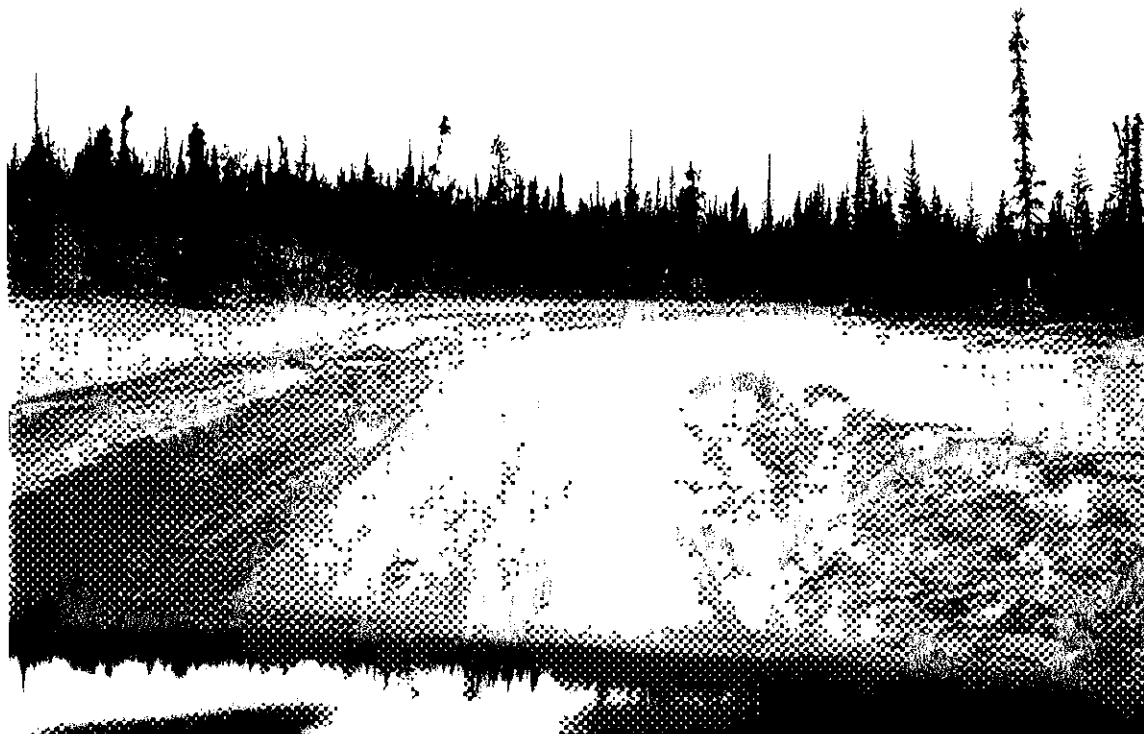
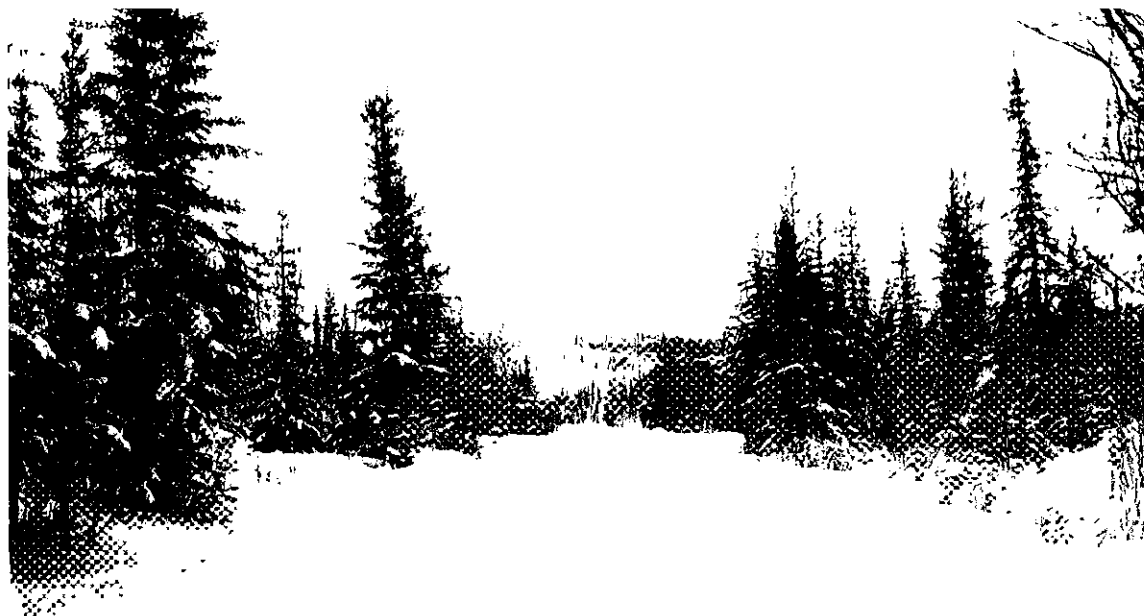
FIGURE 3.2

**PORTAGE SOUTH OF BROWN LAKE
ON WAY TO GORDON LAKE - JAN 1995**

PORTAGE ON WAY TO GORDON LAKE - JAN 1995

Work on the portages was in progress at the time, particularly in the regions of Drybones Hill and Charlie Hill, apparently two of the more difficult portages. The improvements consisted of snow removal, levelling with snow and water and sanding to improve traction. Photographs in Appendix C show some of this process. Examination of the photographs will show that widening of the portages would be necessary to accommodate the large vehicles which would haul BHP's large loads. The vertical curvatures would also cause "high centering" at certain locations, as discussed in the Sandwell August report. In general, though, the portages should be traversable by the carriers.

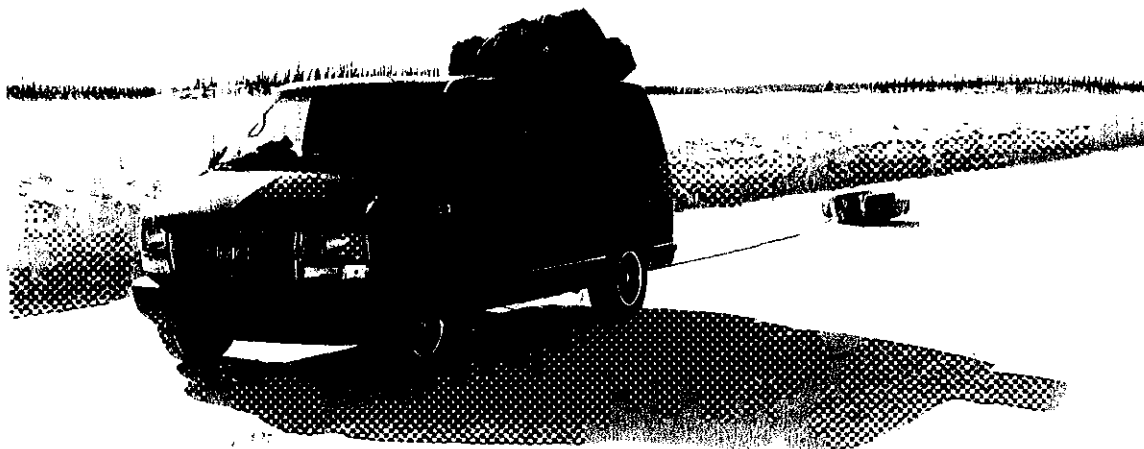
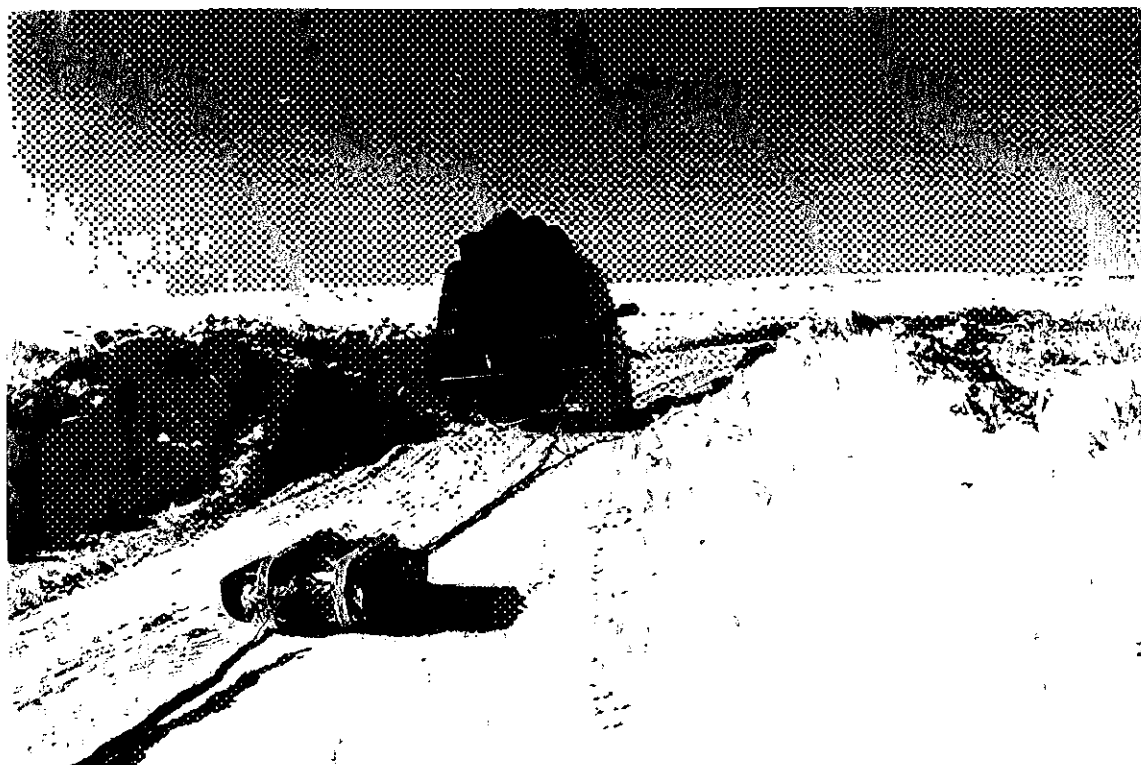
FIGURE 5.1

GROUND PENETRATING RADAR

The survey was conducted using a GSSI Ground Penetrating Radar (GPR) System supplied and operated by Jim Greer through Guben Transport, Tuktoyuktuk, N.W.T. Also present during the survey were Bill Graham and Paul Spencer of Sandwell. The system consisted of a transmitter/receiver antenna unit which was towed 10 m behind the vehicle and an electronic unit mounted in the vehicle. The system is illustrated in Figure 5.1. The unit was manually operated in that the output of the GPR was a trace on the chart recorder. The GPR was powered using the +12 V battery in the vehicle. The unit operates by generating a short high frequency pulse into the ice sheet. Boundaries and objects within the ice sheet can scatter and reflect the radio frequency signal. Some of the scattered/reflected energy is picked up by the receiver antenna. The electronic unit then processes the retrieved signal by providing amplitude/time delay information on the chart recorder (Arcone 1985). The unit was set up so that approximately 30

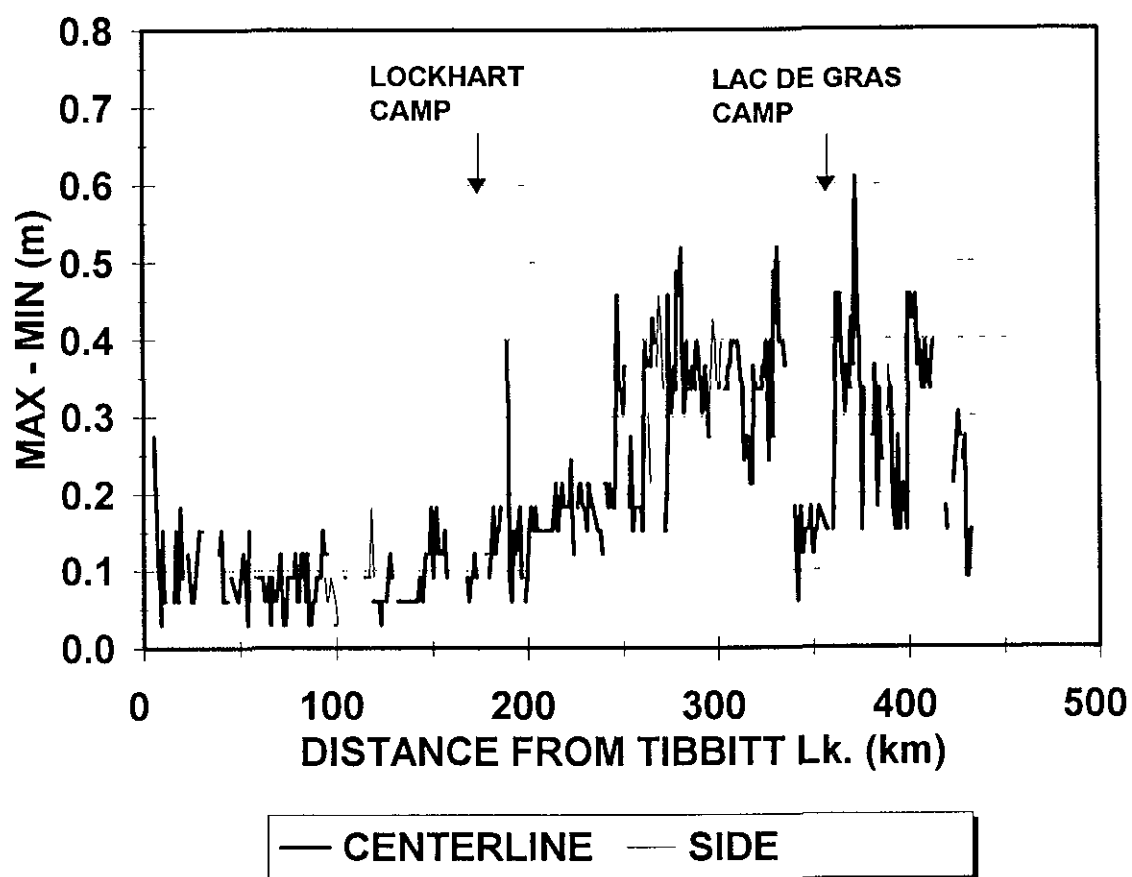
FIGURE 5.5: ICE THICKNESS, MARCH 1995
VARIATION IN THICKNESS
