Dominion Diamond Ekati Corporation

IEMA Workshop
December 3, 2014

Cell B Reclamation & Research

Design and construction of a long term cover on the LLCF with a landscape that will be safe for human and wildlife use

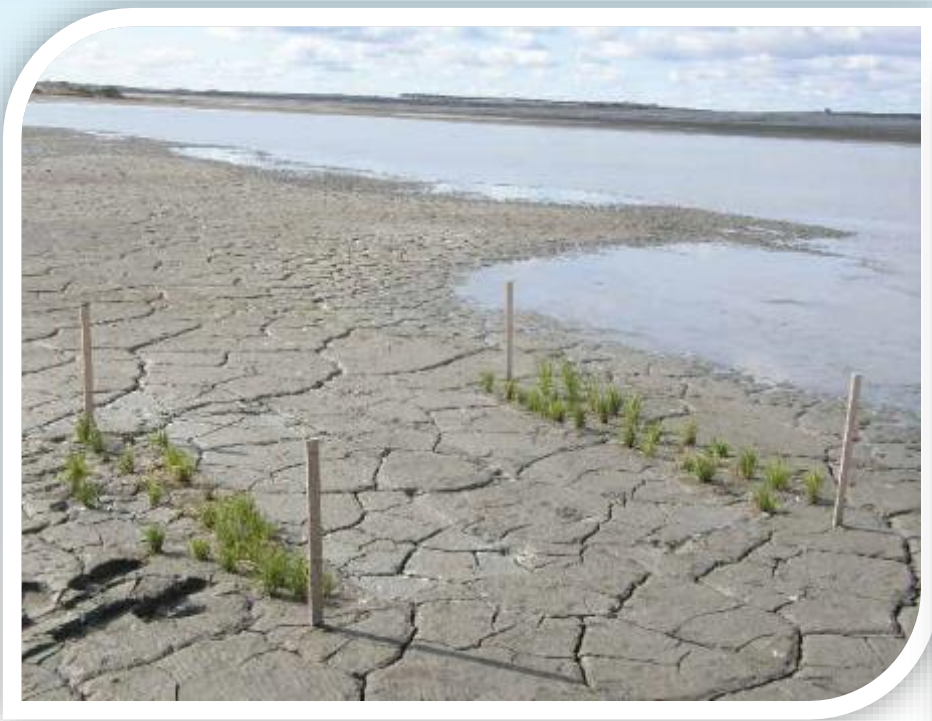
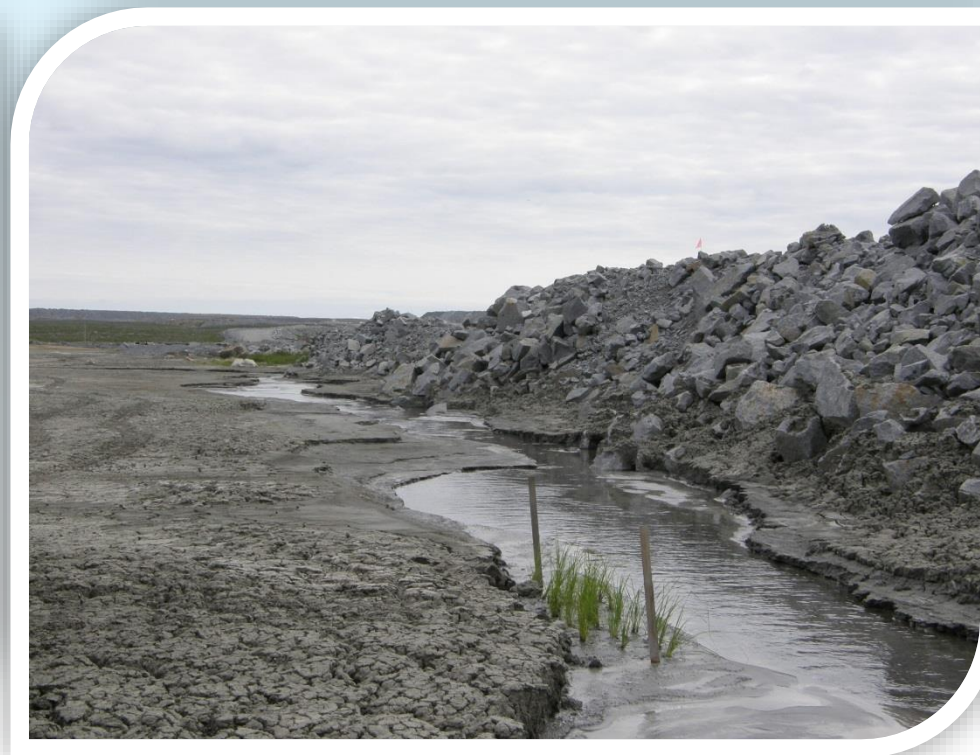
Sedge and Cotton Grass Seedlings

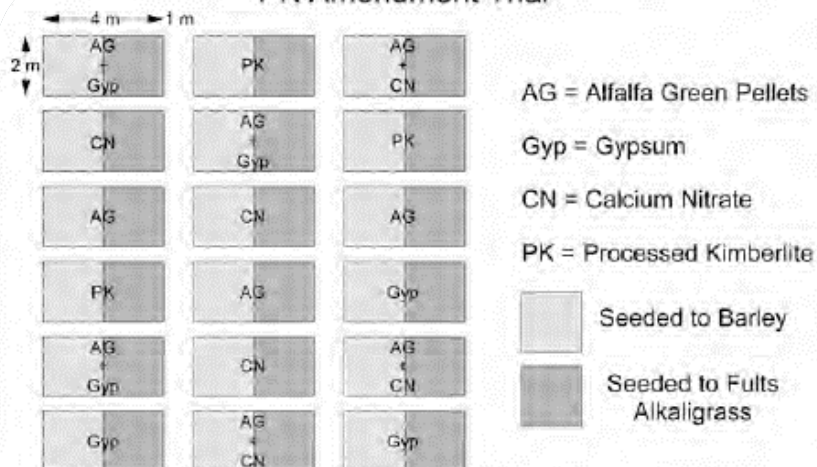
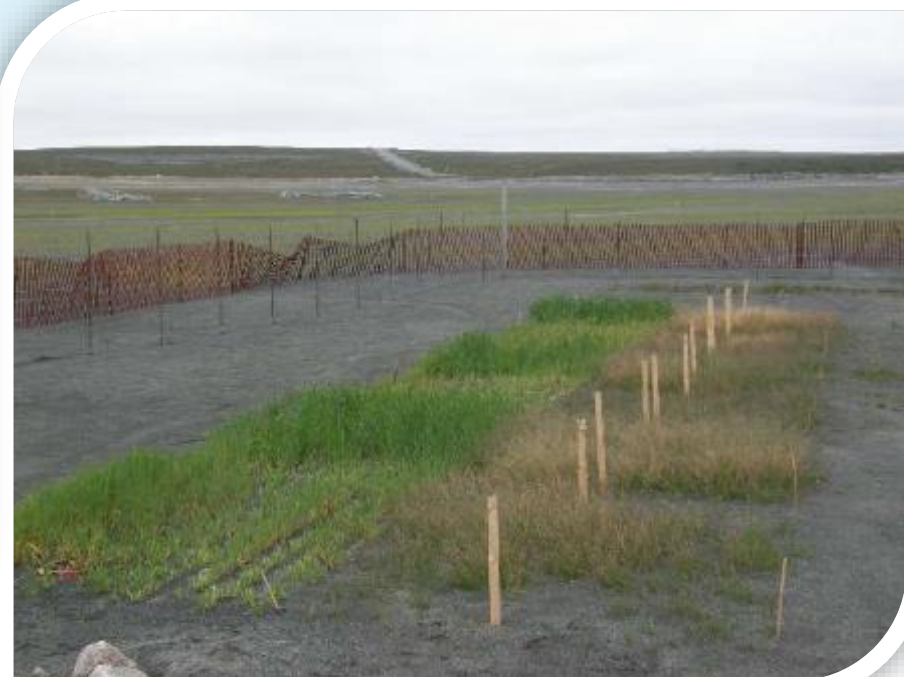
PK Amendment Trial

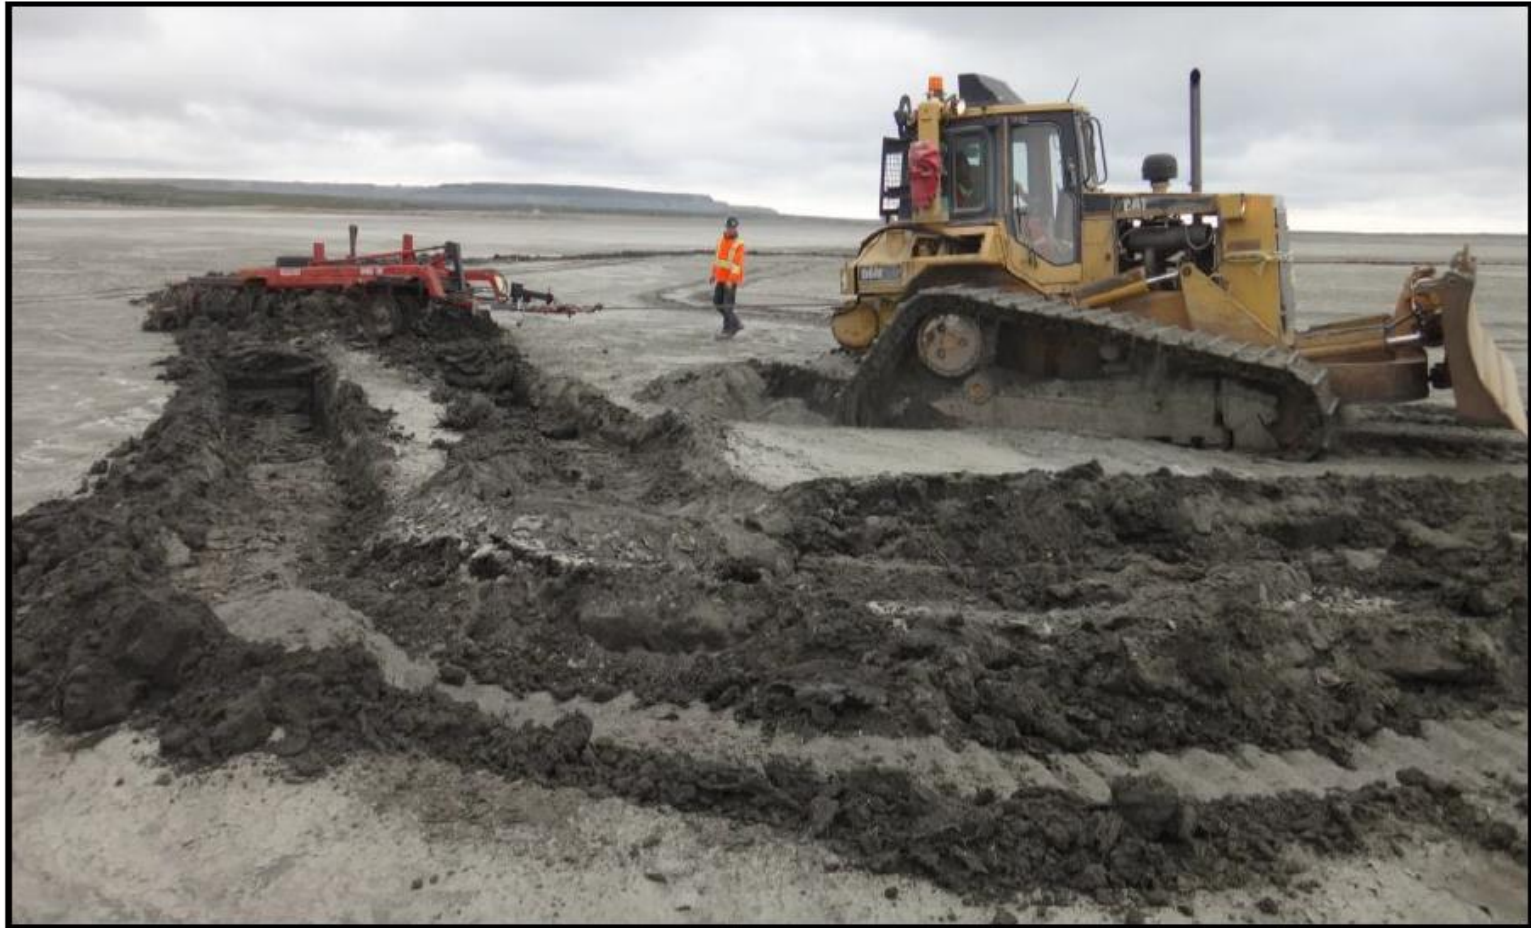
2013 Lessons Learned (D6 & Breaking Disc)

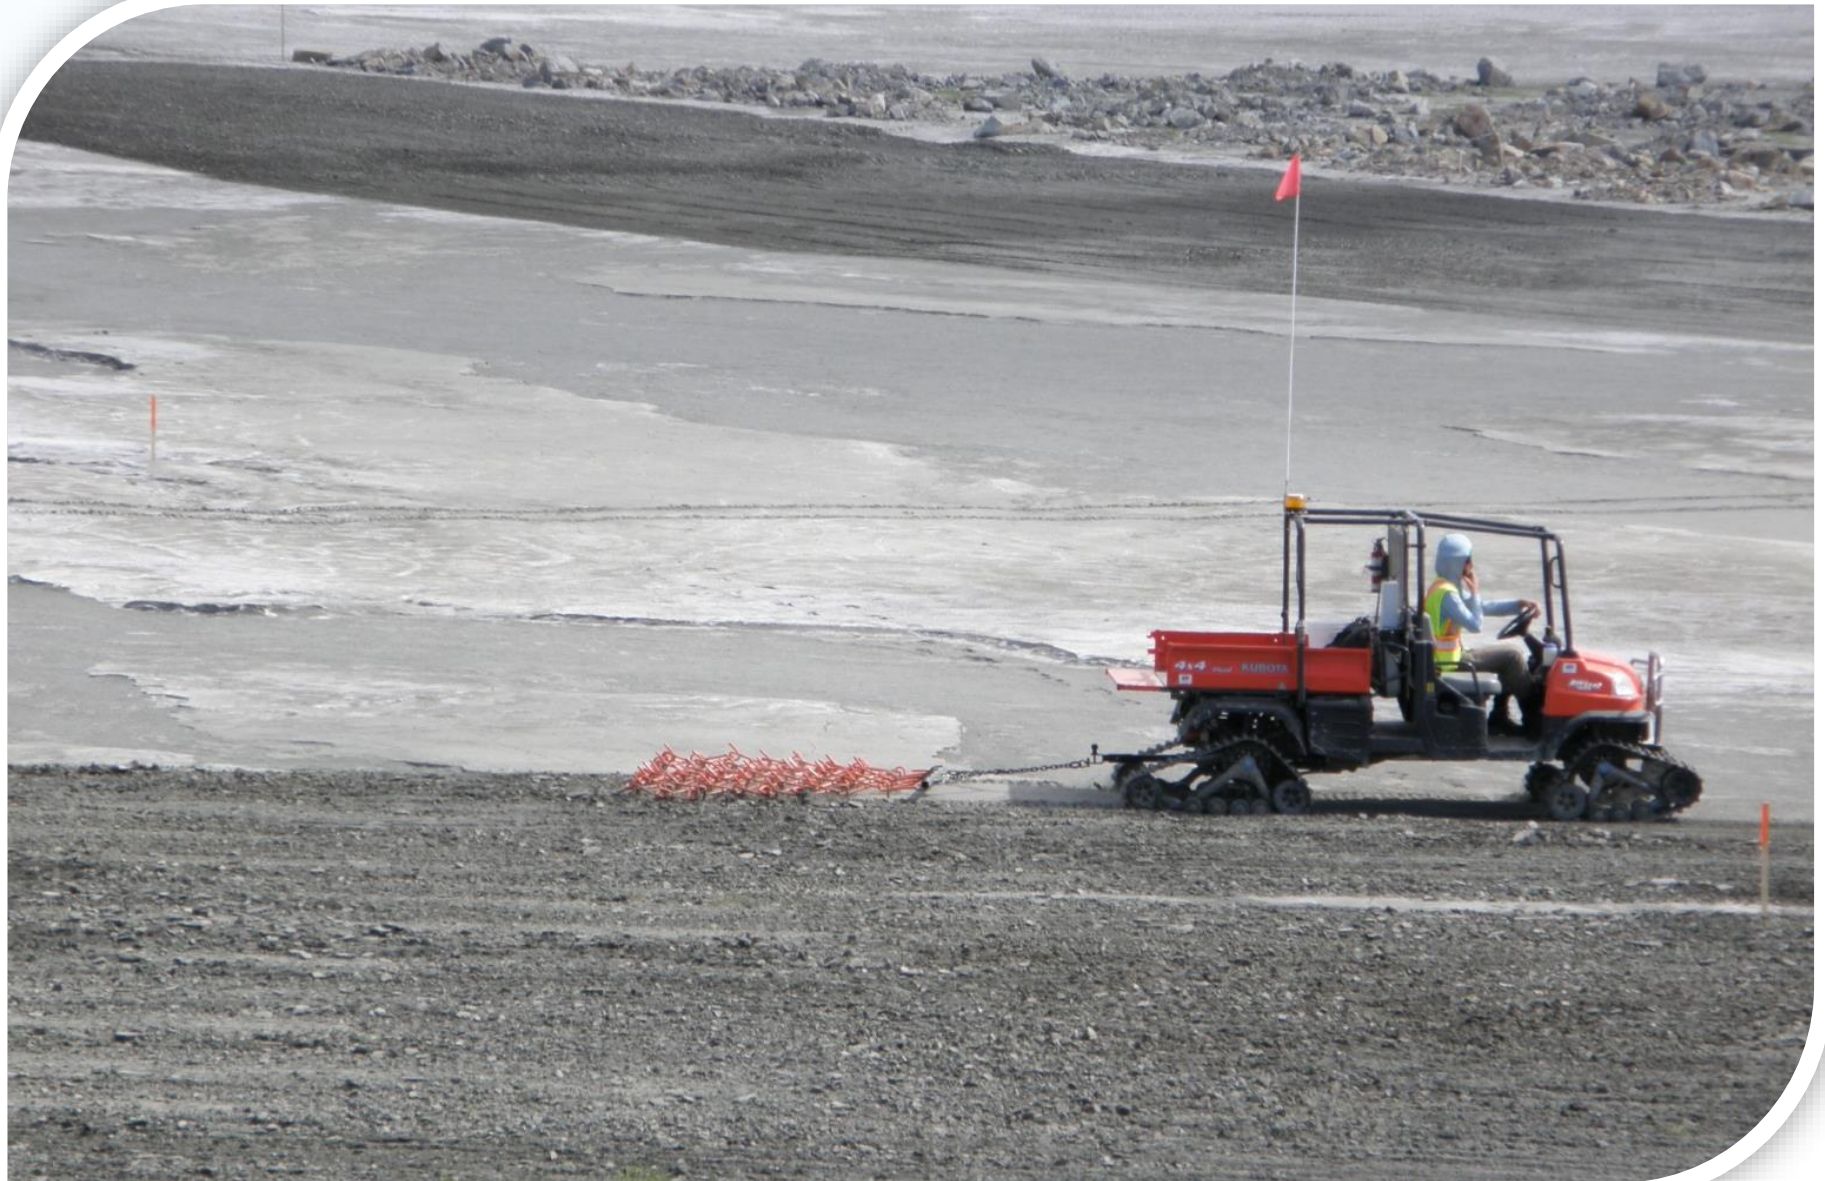
Step 1: Harrowing (Initial Soil Break Up)

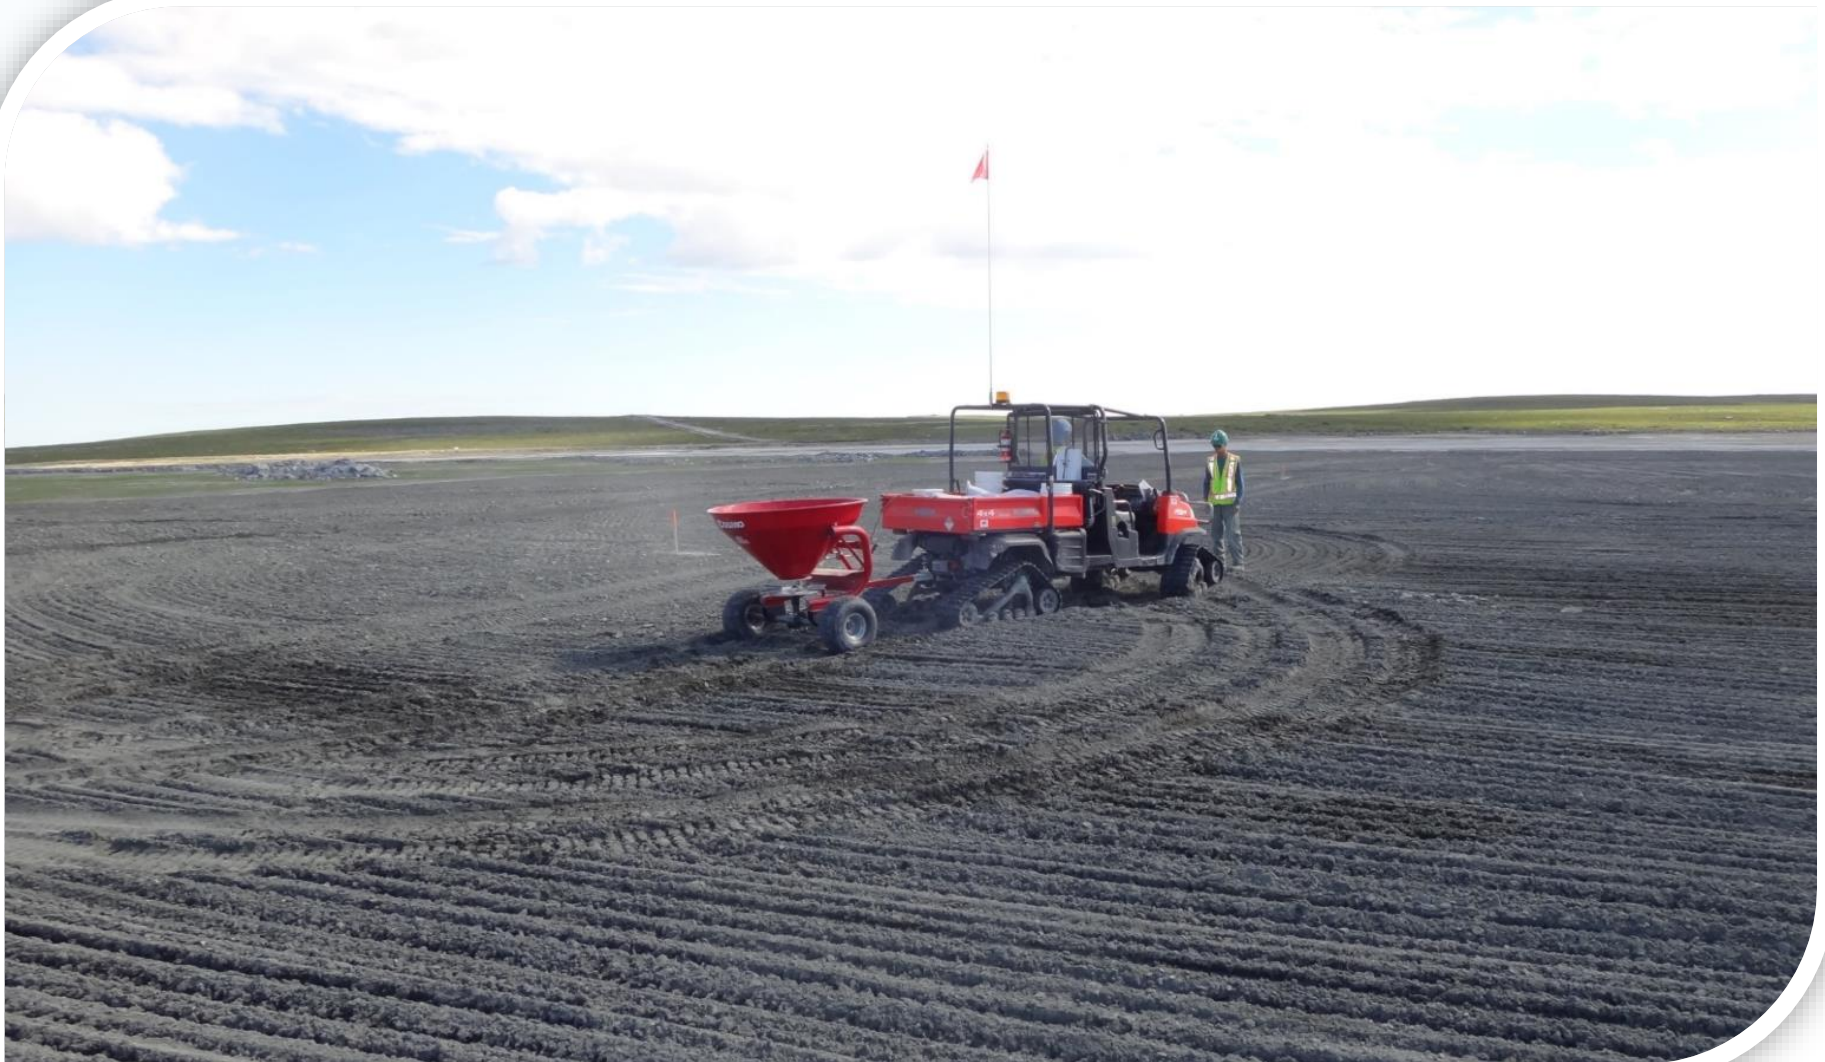
Step 2: Broadcast Seeding

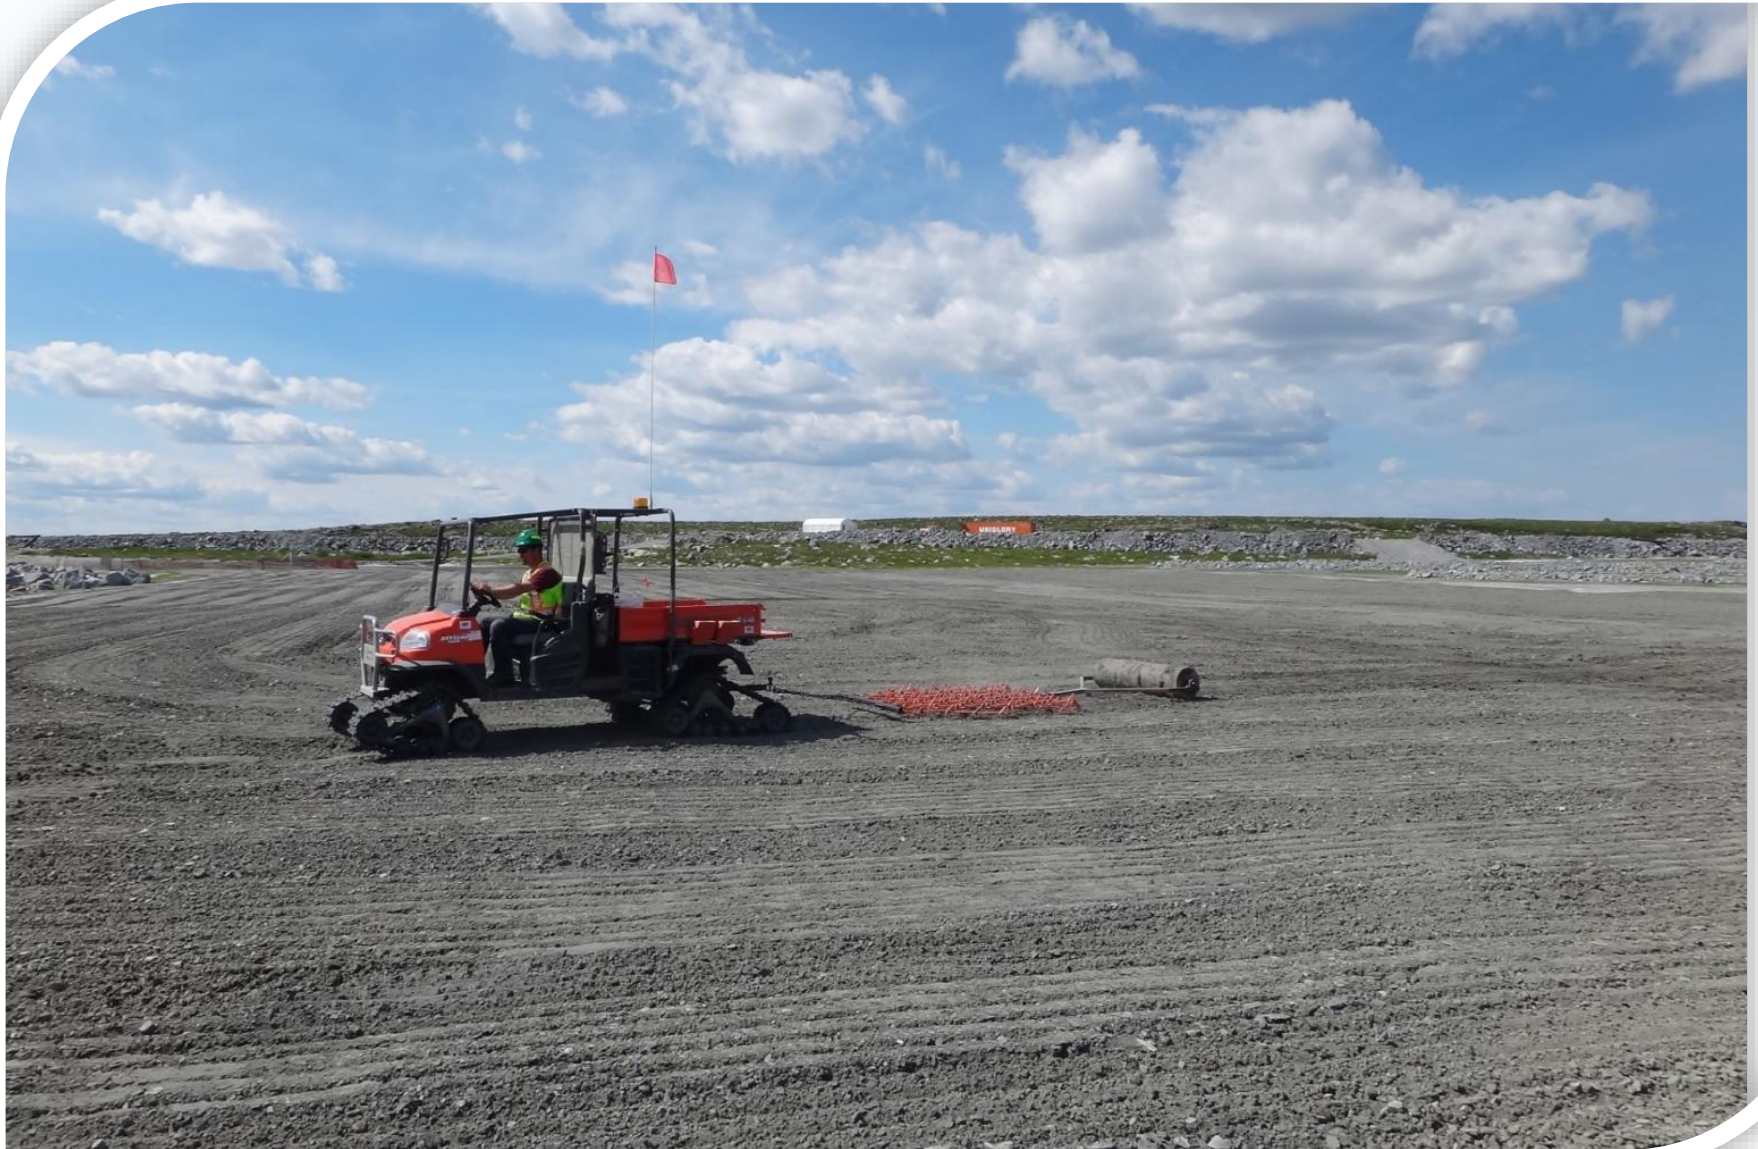
Step 3: Harrowing and Rolling

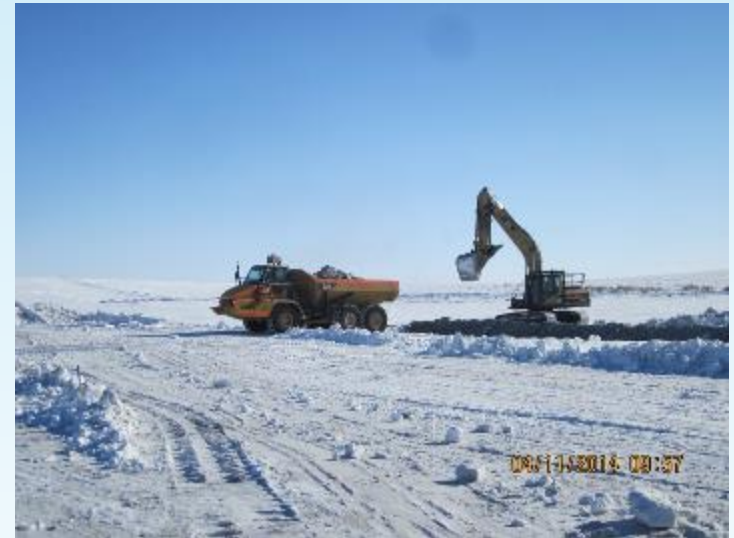
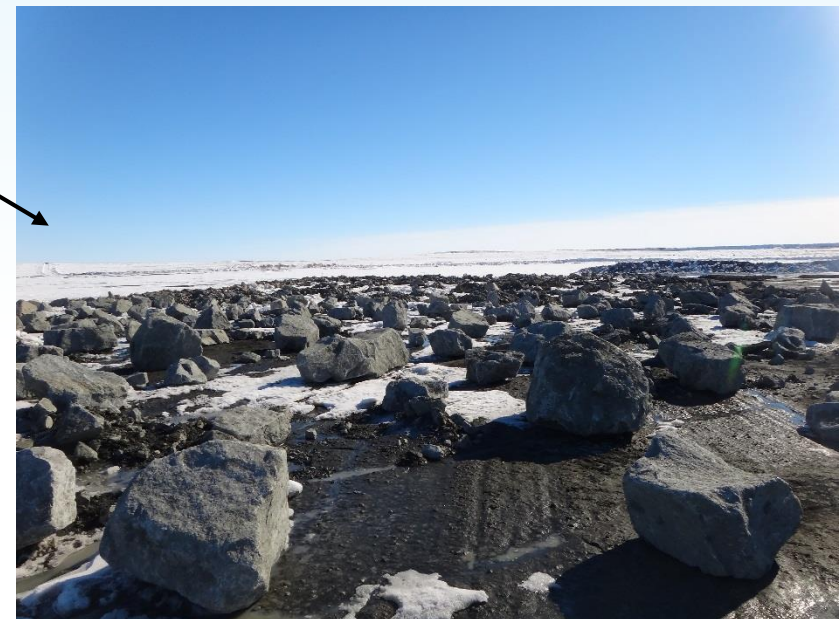
2013: Rock Placement

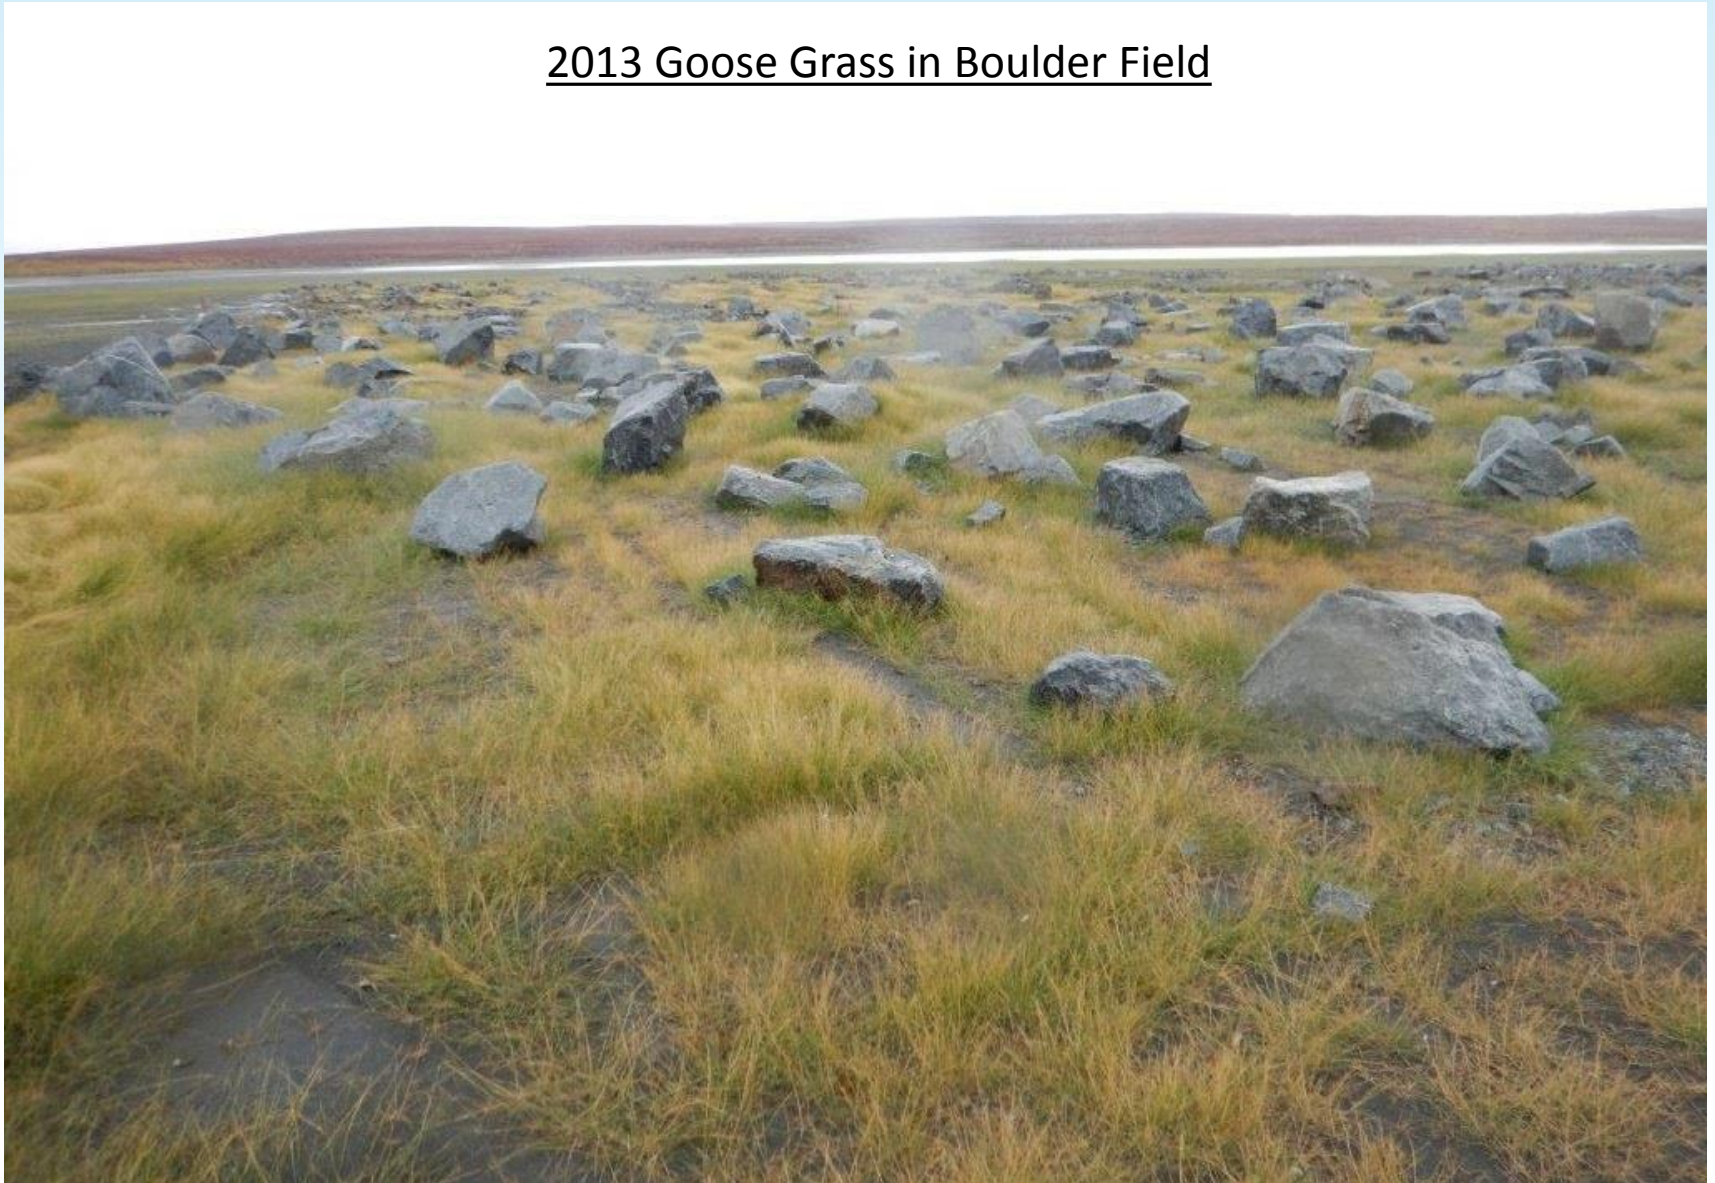
2013 Goose Grass in Boulder Field

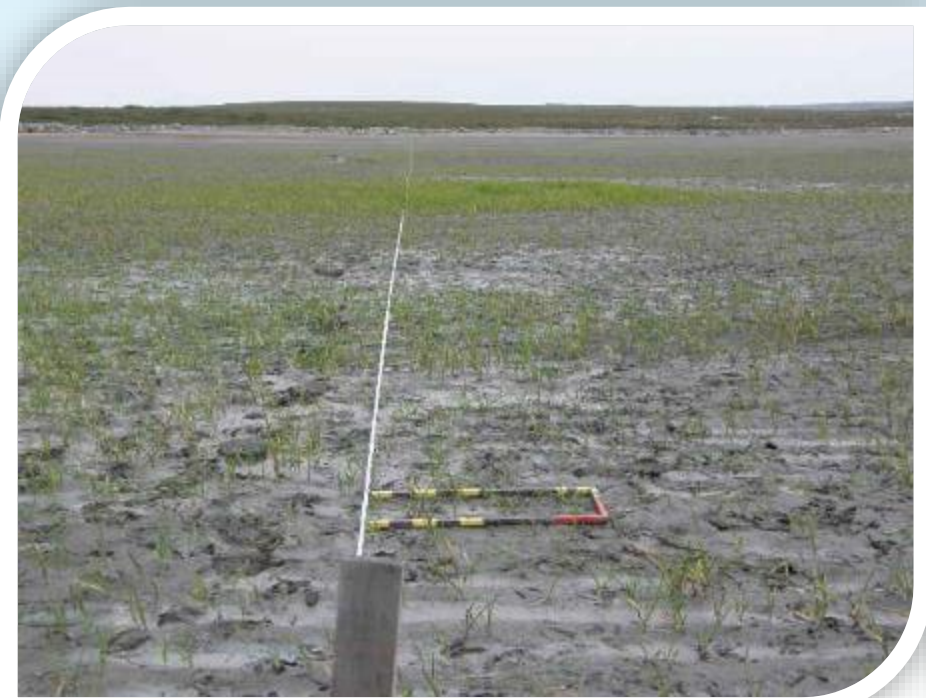
2014 Barley

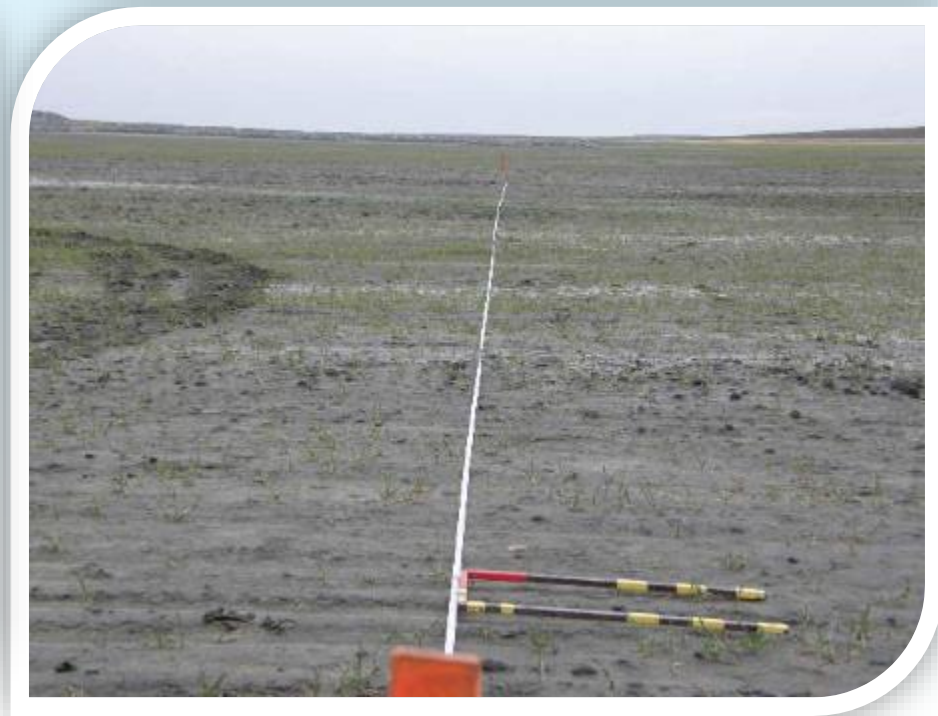
2014 Fall Rye

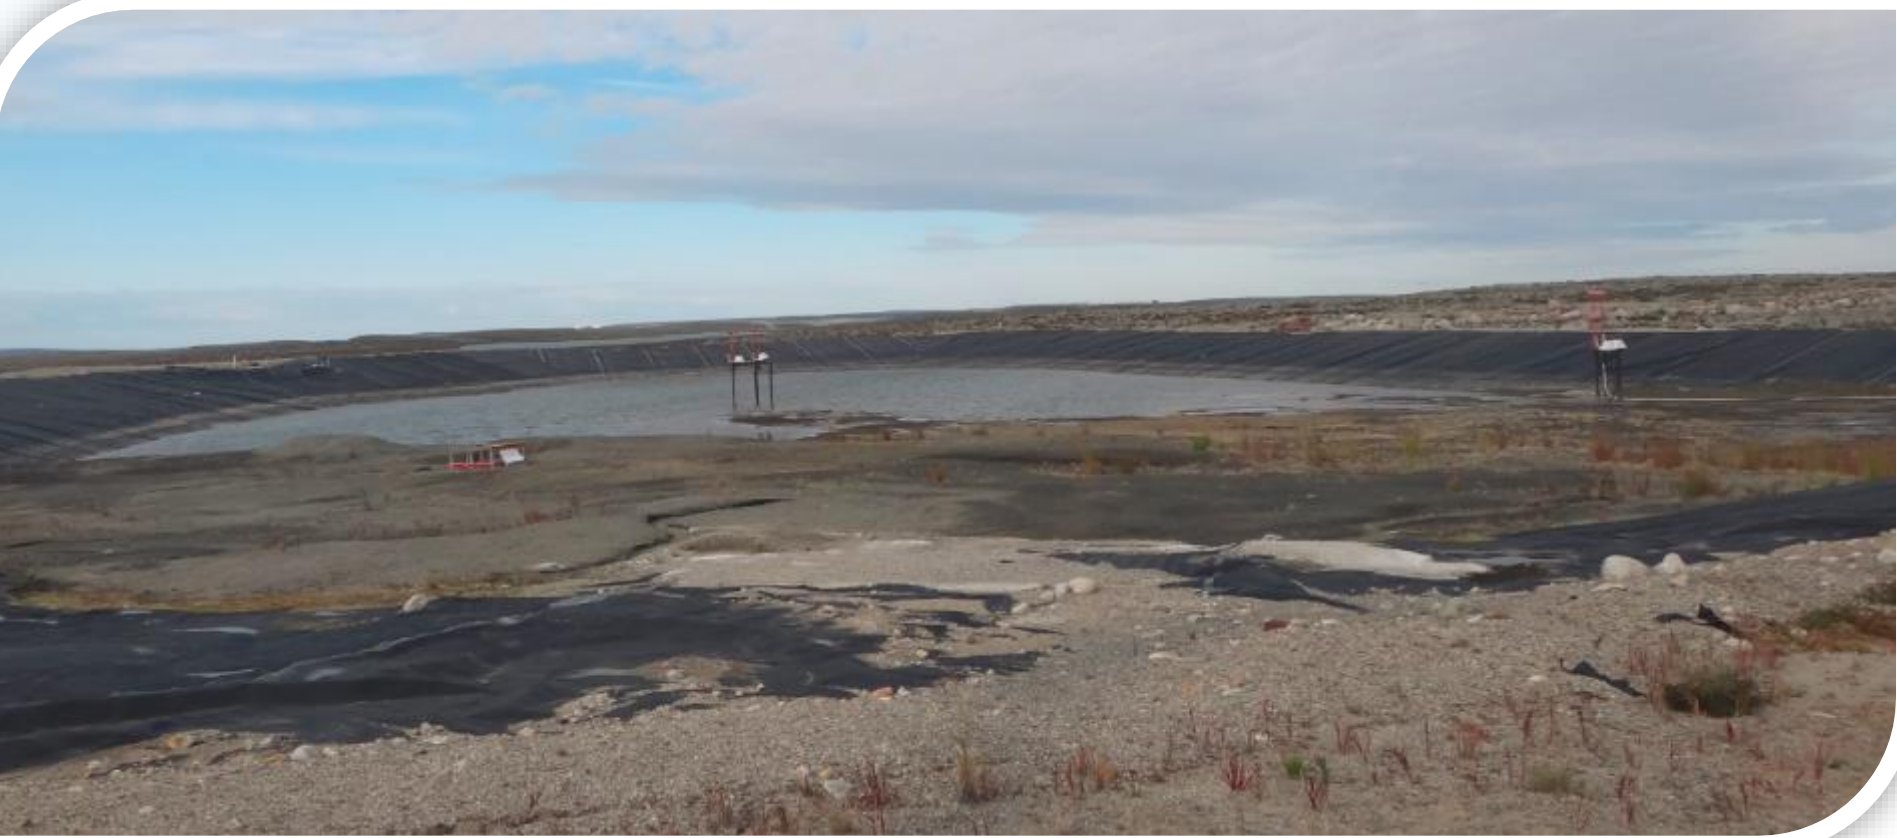
South Pond Before Reclamation

- Old Camp Closure and Reclamation Plan Approved by WLWB on April 14, 2014
- Reclamation of the South Pond PKCA commenced in July of 2014 and ended in October
 - Upgrades to Haul Road
 - Change Management Plan for Airport Traffic
 - Pumping out of Water
 - Removal of Processed Kimberlite (PK)
 - Removal of Liner Materials
 - Breaching of South Berm
 - Grading of esker berms to promote natural drainage
- Remaining Activities for South Pond
 - Channel construction to route runoff through the reclaimed area
 - Minor grading and housekeeping of liner debris
 - Water quality monitoring

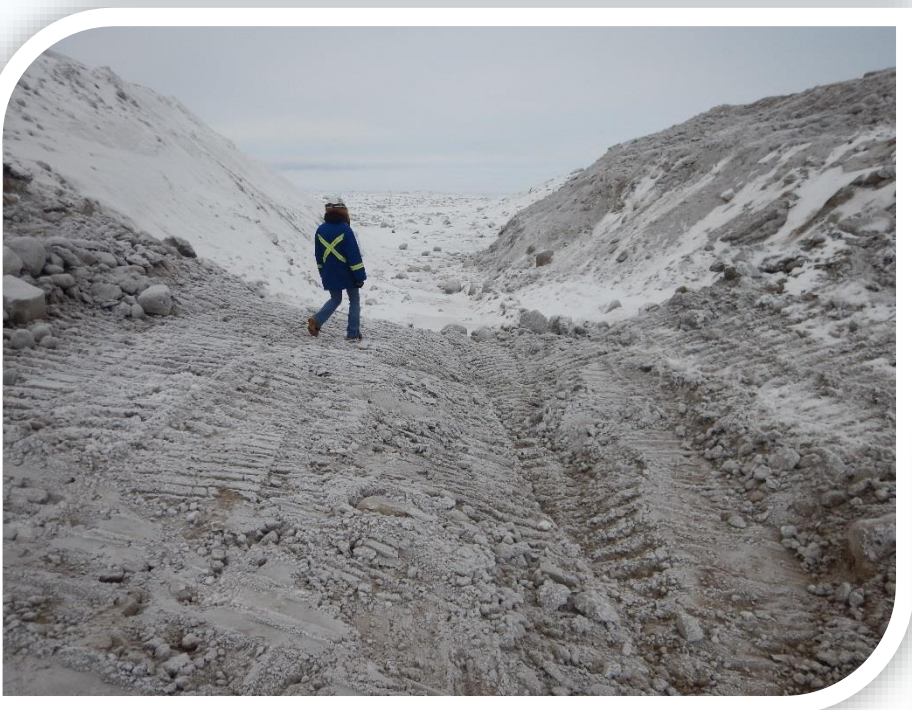
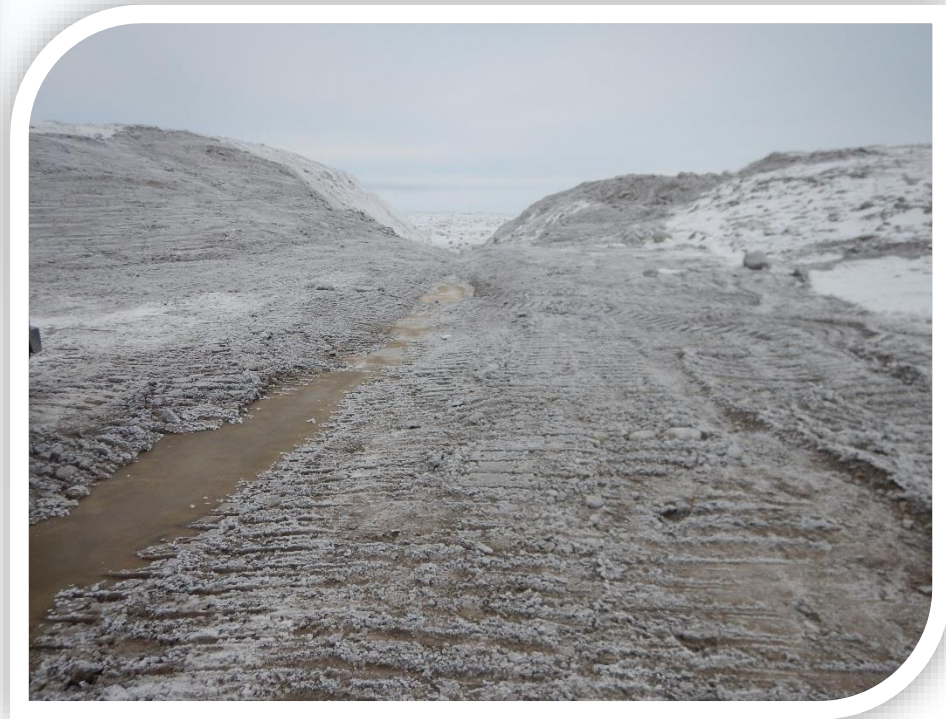
After Reclamation Breached South Berm

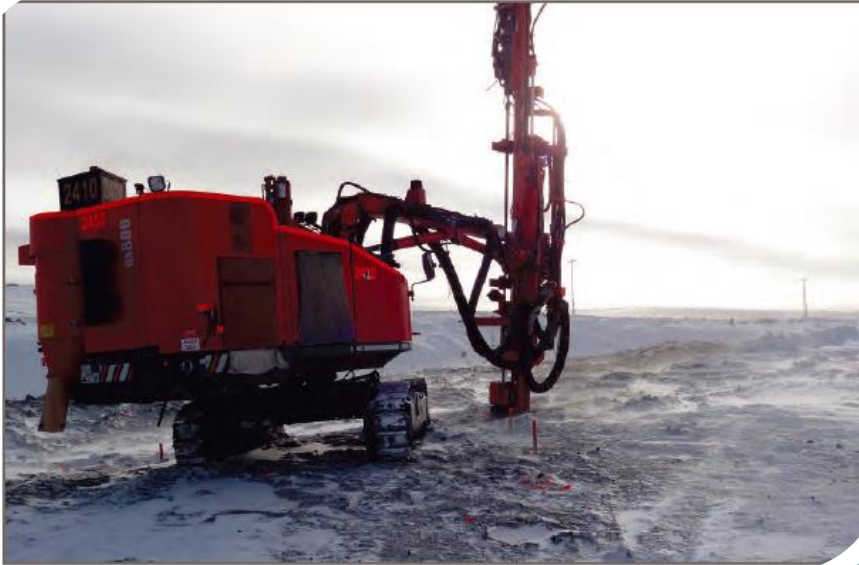
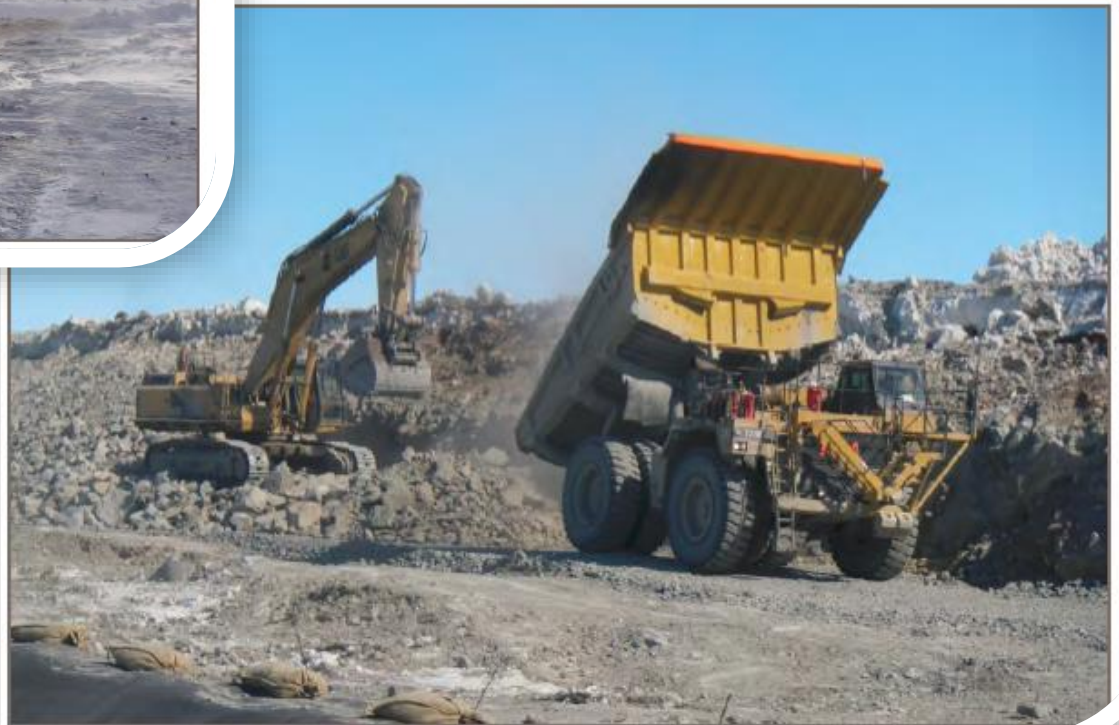
Mining Activities

- Final Phase III of construction was completed from January to May 2014
- PDC construction was conducted according to Construction Drawings and Specifications
 - **Site preparation** included ice pad and access road
 - **Mining activities included** drilling, blasting, excavating and hauling, scaling, defining the lower slope and bulk clean-up
 - **Material placement** which included placement of erosion protection and waste rock fillets, grading and sediment control berm construction
 - **Clean-up activities** which included protective ice pad clean-up and notching the ice pad for freshet flow.
- Construction report for all three construction phases was submitted to DFO and the WLWB in October of 2014
- Relinquishment of financial security for Panda Division Channel Stabilization will be requested as part of the 2014 Annual Progress Report.

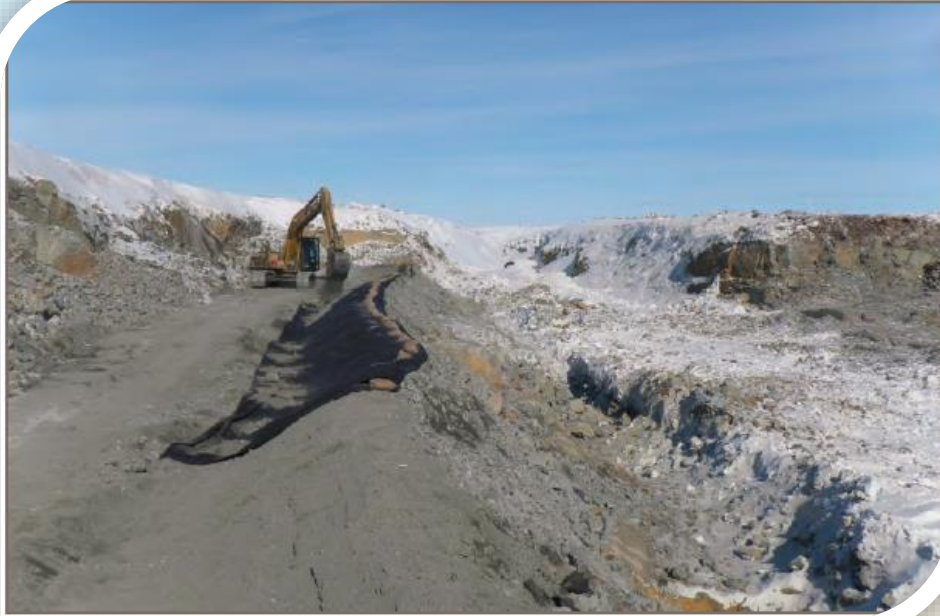
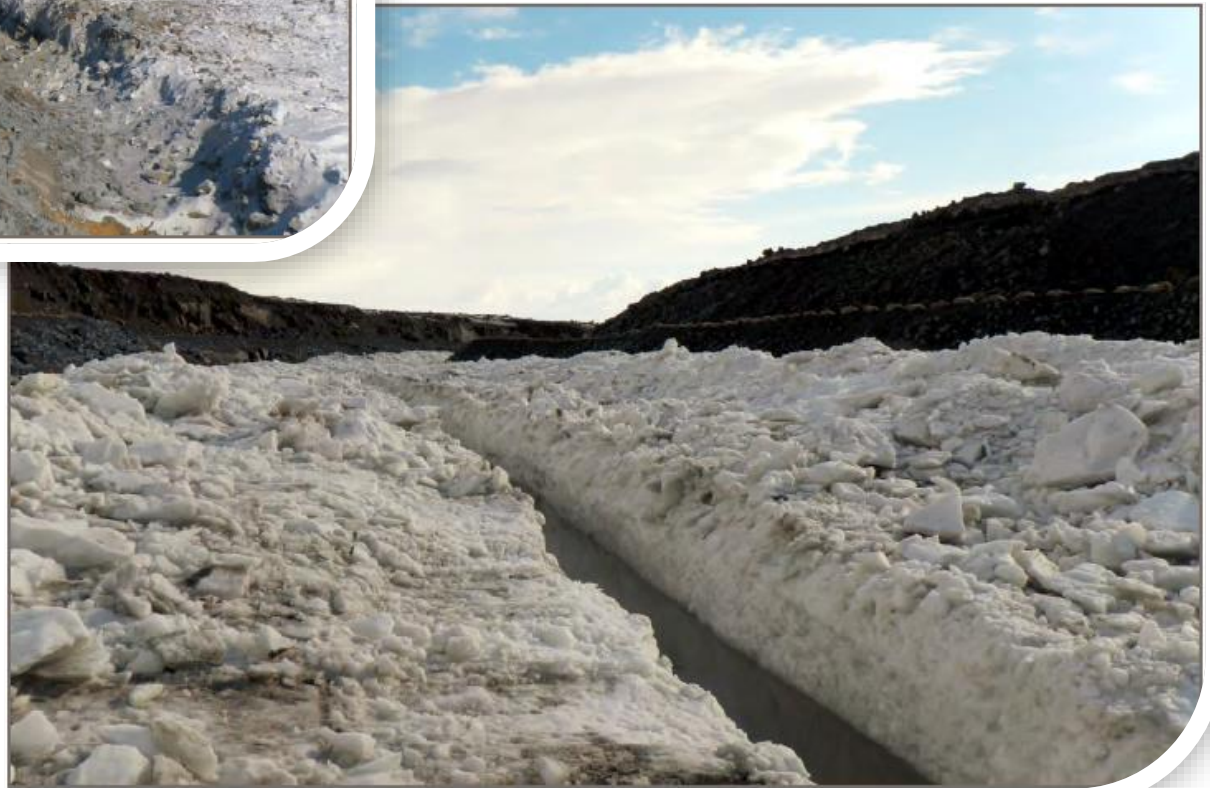
Material Placement and Clean Up
